MONITORING MISSION REPORT

Zamzam IDP Camp (Abuzireg and Tewila gate)

Date 05/05/2015

Up grading of hand pump in to Mini water yard

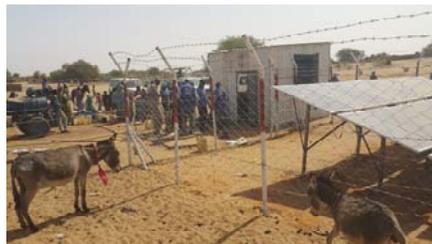
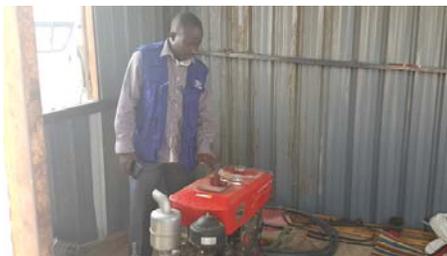
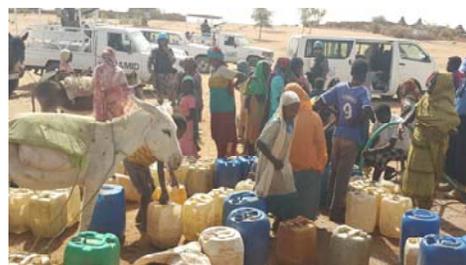
- Located in Abuzireg gate;
- It is one of the water point intended to be upgraded under the project;
- 30 Solar modules (Blue sun product, poly crystalline type) each with 100 watt capacity and inverter installed, making the total power supply 3kW;

- The Solar modules are installed on metallic stand and well protected by fence;
- The system fitted with one backup generator;
- The motor house constructed;

- The distribution points/ tab stands and service tanker not yet constructed;
- The system has remained functional for the last 15 days (works from 8:30AM to 6:00 PM) and no technical problem encountered so far¹;

- The discharge is around 1.5 litter per second;
- People are using the water scheme;
- The water point overcrowded by people comes to fetch from the water point. This might be due to the absence of proper distribution facility (it is already in the planned to construct tab stand with 10 faucet);

- As the estimation of water committee, 2000 to 2500 people come each day to take water².

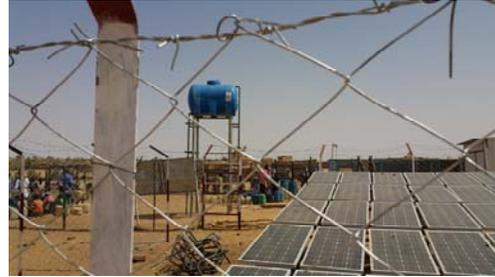
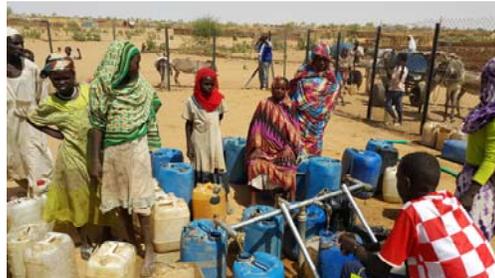
- Located in Tewila gate;
- 30 Solar modules (Blue sun product, poly crystalline type) each with 100 watt capacity associated with inverter installed, making the total power supply 3kW;

- The Solar modules are installed on metallic stand and well protected by fence;
- The system has neither backup generators nor power storage apparatus;

- The motor house constructed;
- The system is connected to two tab stands having 12 faucet;
- The scheme has one elevated plastic water tanker with the capacity of 2 cubic meters and one bladder of 10 cubic meter capacity;

- The system has remained fully functional for the last two months (working hours: from 9:00AM to 6:00 PM) and no technical problem encountered so far³;

- The scheme is fenced and one sign-board having the logo of IOM, WES and Japan is fixed;⁴
- People are using the water scheme and overcrowded by people come to fetch from the water point;

- As estimation of water committee, 2000 people come each day to take water.

⁴ In fact, other one sign board depicting the scheme for being constructed by WES and UNICEF is also there, I will discuss with WES and UNICEF to resolve the issue
